**LEVEL II**  
BOYDSTOWN DAM

NDI No. PA 00270  
PennDER No. 10-1

**PHASE I INSPECTION REPORT**  
NATIONAL DAM INSPECTION PROGRAM

AUGUST 1979

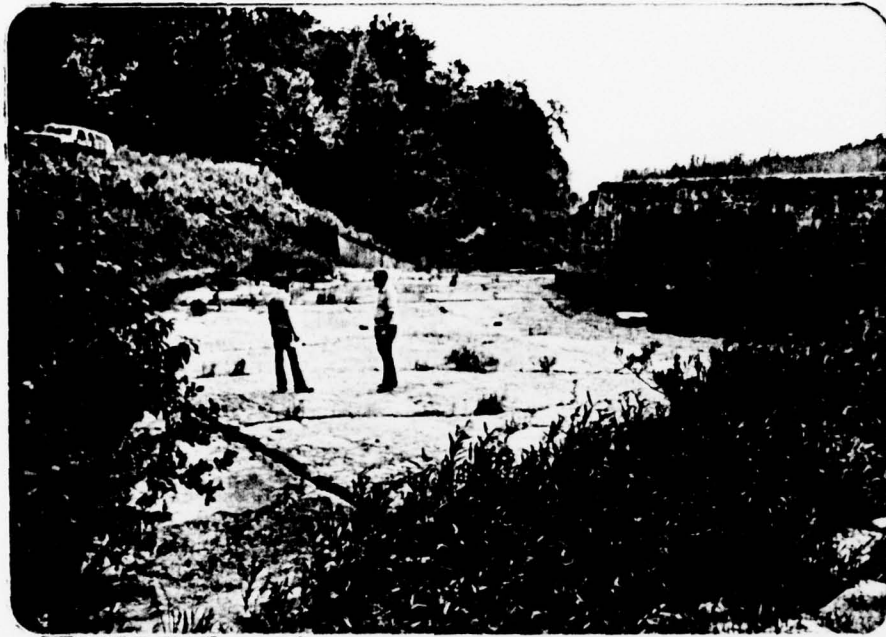
PHOTO 1. View of Spillway Looking Downstream

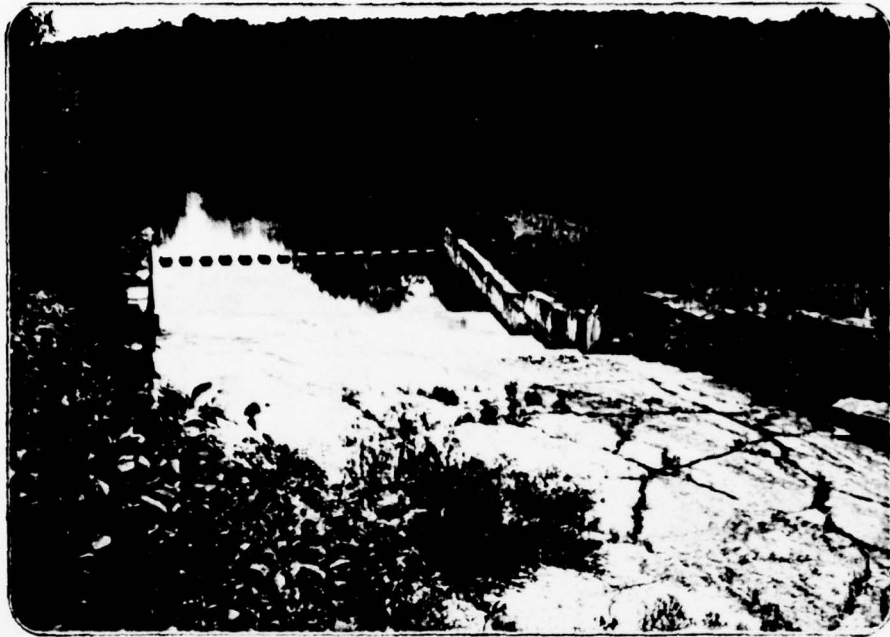
**PHOTO 3. View Looking Downstream at Spillway Discharge Channel and Stilling Basin**

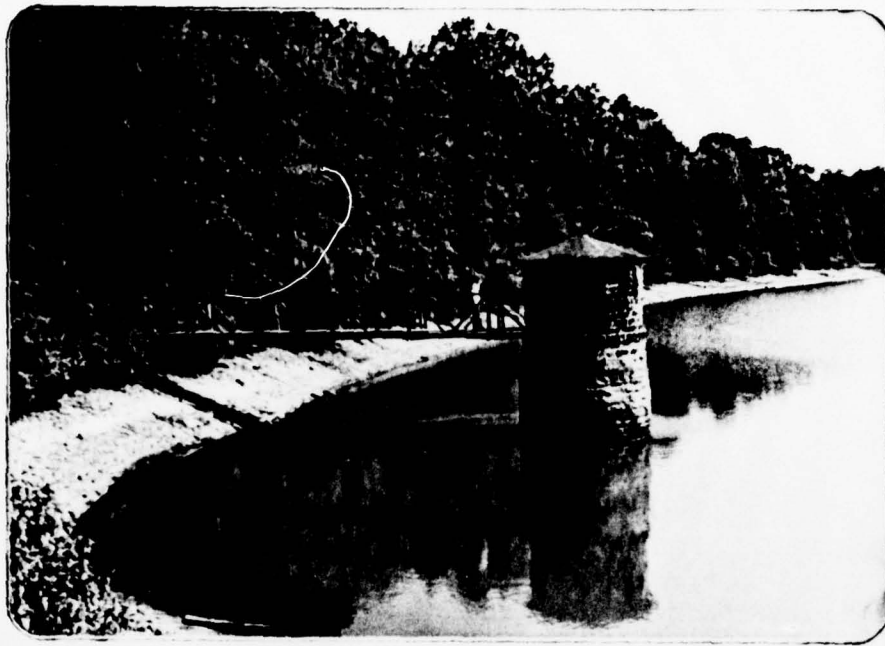
The intake tower was in fair condition with only a couple of boards on the walkway to the tower starting to rot away. The mortar between the

stones appeared to be in fair condition; however, the submerged portion of the tower could not be checked. The valve stem for the lowest level intake was disconnected at the time of the inspection. The remainder of the valves (gates) appeared to be functional but in need of preventive maintenance.

PHOTO 5. View Looking Upstream at Intake Tower

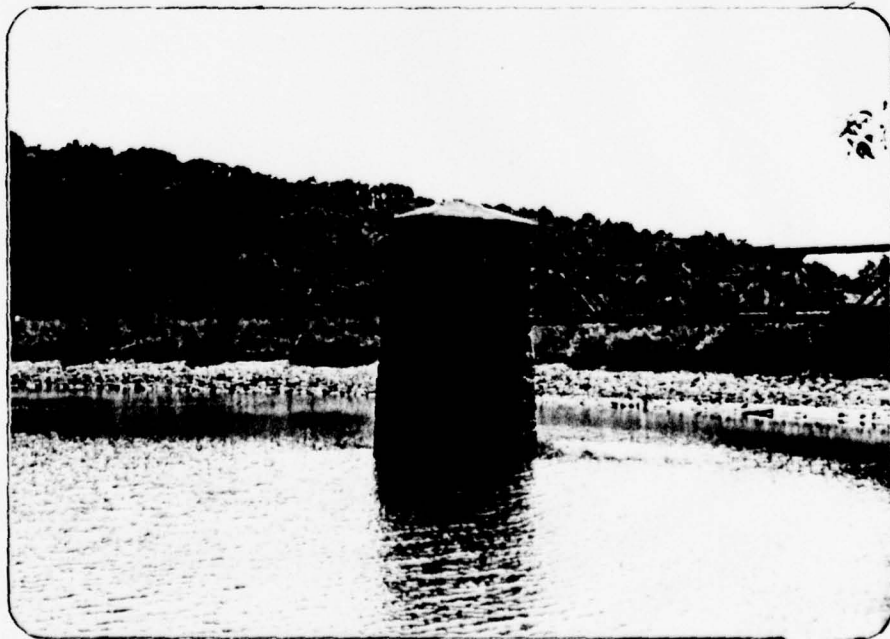
PHOTO 6. View Looking Downstream at Intake Tower and Upstream Slope of Embankment

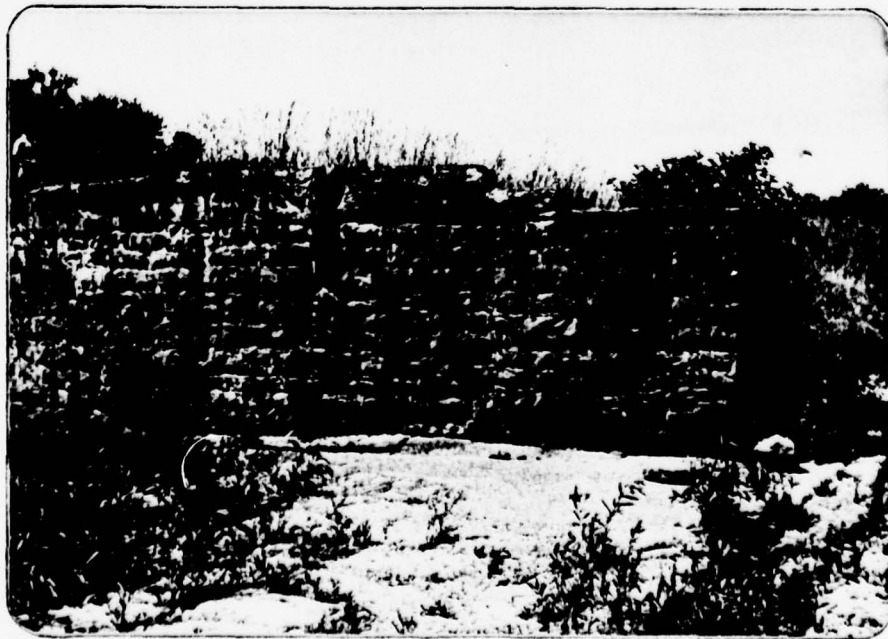
- c. Visual Observations - The right training wall of the spillway, near the control section, is cracked and horizontally separated at the top of the wall by several inches. Generally, the upper end of the spillway is deteriorated and in poor overall condition. Structural failure of the spillway could possibly occur in the event of a storm equal to or greater than that of 1954.
- d. Overtopping Potential - Boydstown Dam is a "Small" size - "High" hazard dam requiring evaluation for a spillway design flood (SDF) in the range of the 1/2 Probable Maximum Flood (1/2 PMF) to the Probable Maximum Flood (PMF). Oneida Dam, located immediately downstream from Boydstown Dam, is an "Intermediate" size - "High" hazard dam which has been evaluated

PHOTO 10. Close-up View of Right Training Wall at the Entrance to Spillway Channel

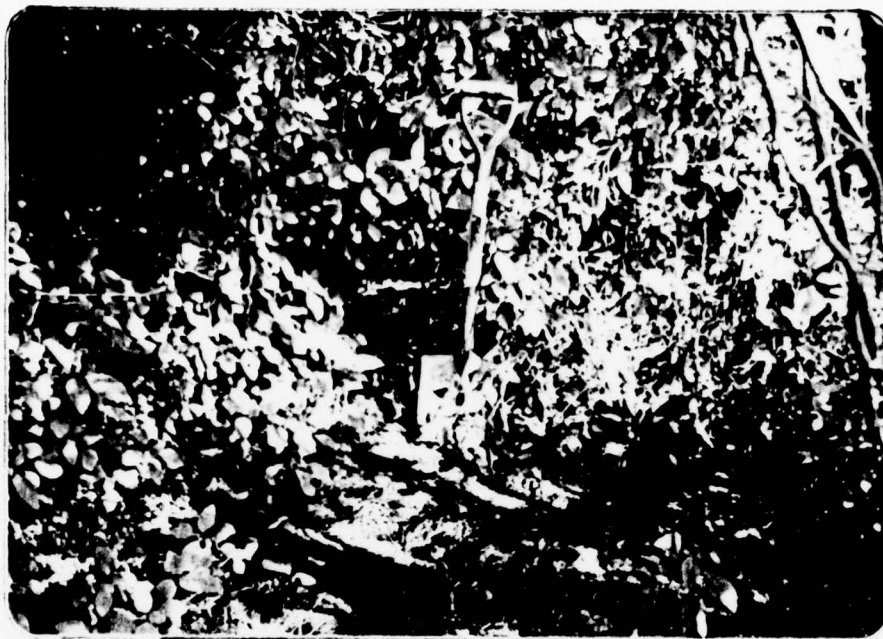
- b. Dam - Clear seepage was observed exiting from the toe of the right hillside approximately 50 feet downstream from the junction of the embankment and right abutment. The estimated rate of flow was 2 g.p.m. from a fractured sandstone formation.

**PHOTO 11. View of Seepage from Right Abutment Toe Area**

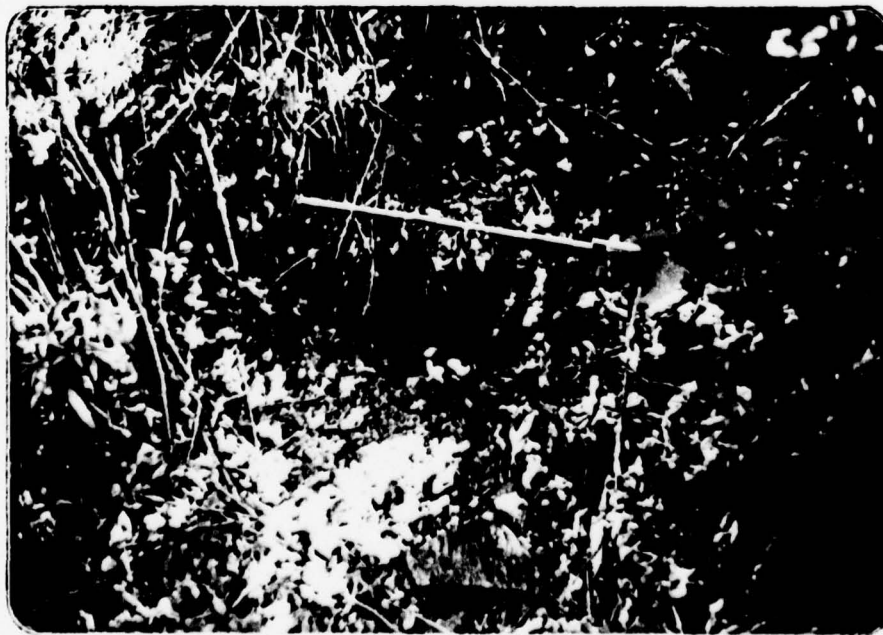
**PHOTO 12. Close-up of Right Abutment Toe Area**  
(Note: Seepage is located near fragmented sandstone.)
